Real Time Water Quality Monthly Report for Voisey's Bay Nickel Company Ltd. October 2004

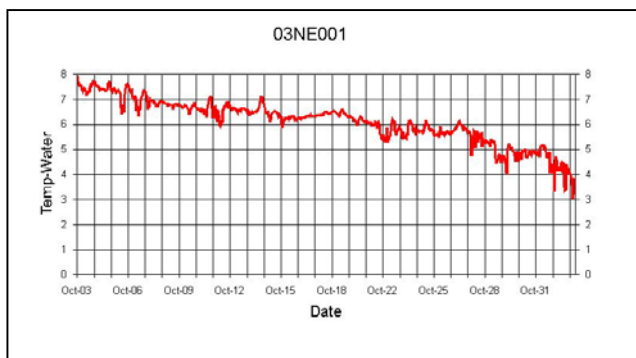
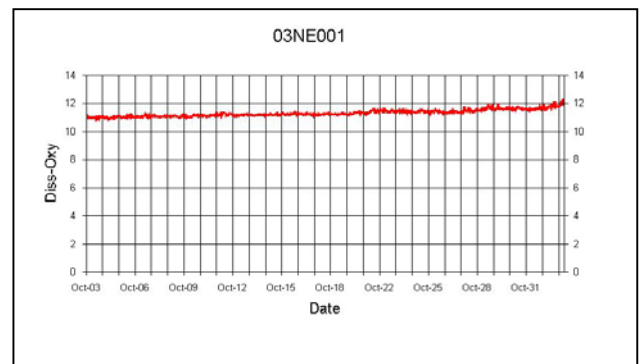
- Throughout the month of October, there was very little activity with respect to water quality at the control station – Upper Reid Brook.
- As expected, due to a drop in the water temperature over the month, the amount of dissolved oxygen in the water slightly increased (Figure 1 and 2).

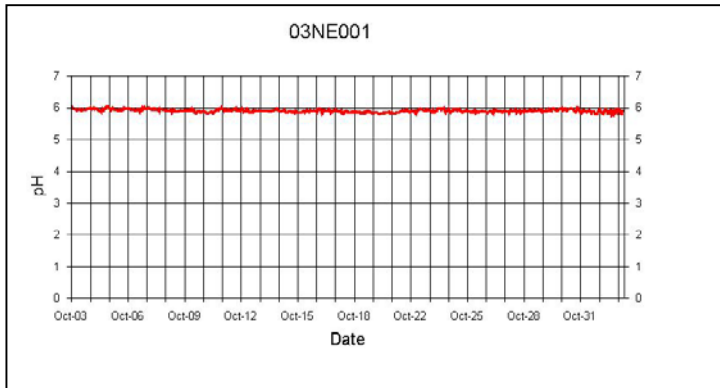
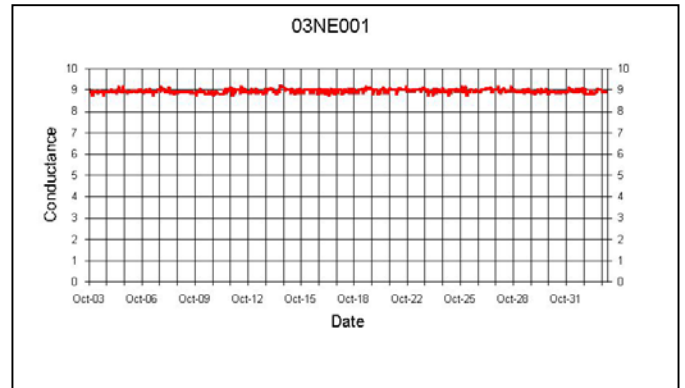
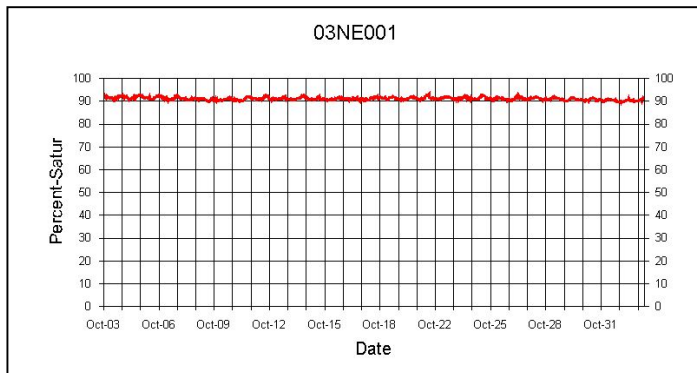
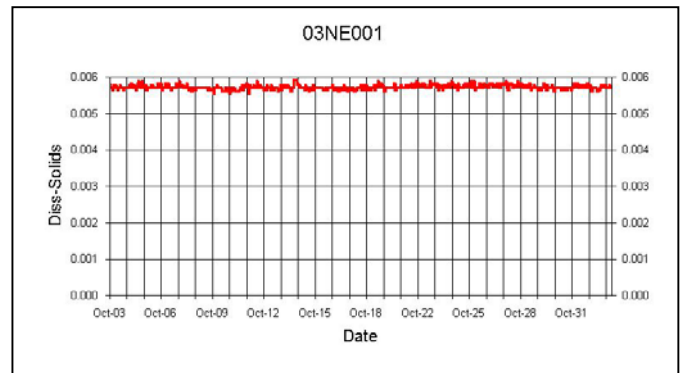
- The pH, conductivity, % saturation and total dissolved solids remained very steady at background levels throughout October (Figures 3, 4, 5 and 6).

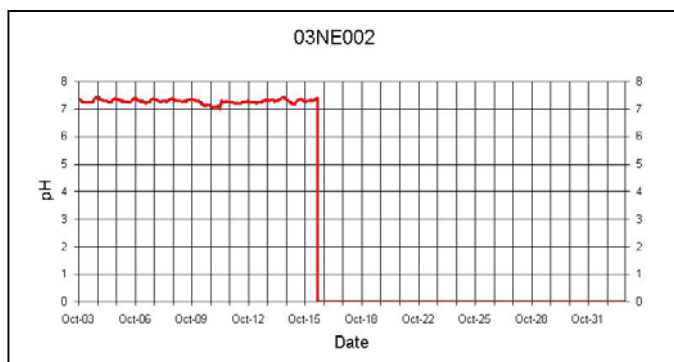
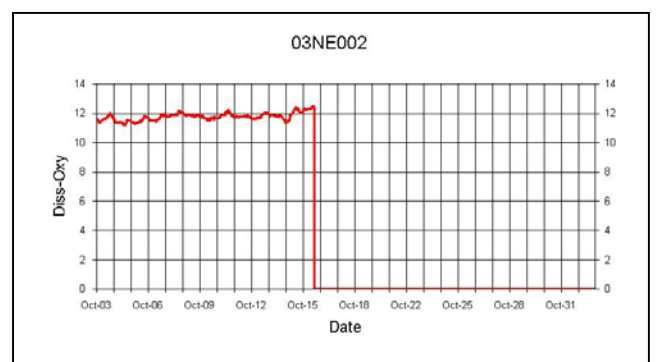
- As stated previously, the instrument at the Camp Pond Brook station was removed in mid-October for use in a training course, thus the graph dropped to zero on October 15th, 2004. Throughout the early part of October, the pH and dissolved oxygen remained very steady (Figure 7 and 8).

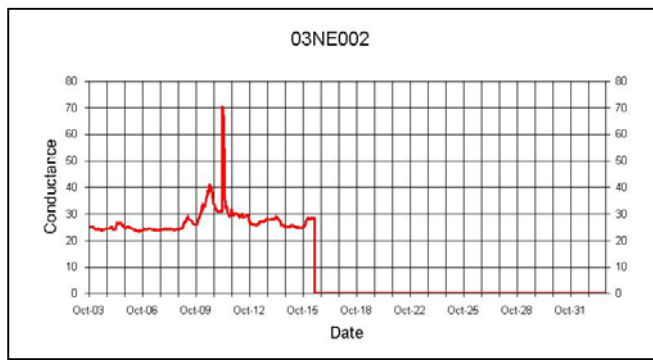
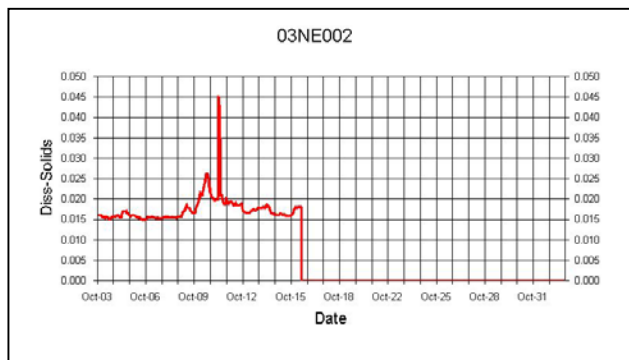
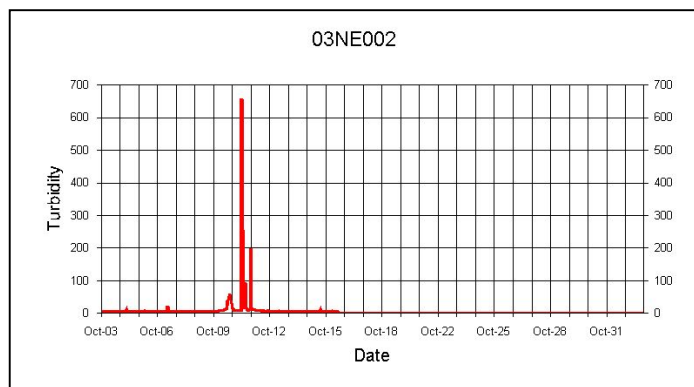
- There was one water quality event on October 10th and 11th, 2004 at Camp Pond Brook that can be clearly seen on the conductivity, total dissolved solids and turbidity graphs (Figures 9, 10 and 11). The turbidity values spiked most noticeably to a value of 657 NTU but then dropped significantly in a one-hour period. The spikes in the graphs are all related to a failure of the generator used to power pumps located in the temporary sumps near Camp Pond Brook. It is important to note that this was a short water quality episode. The mechanical problem was rectified quickly.

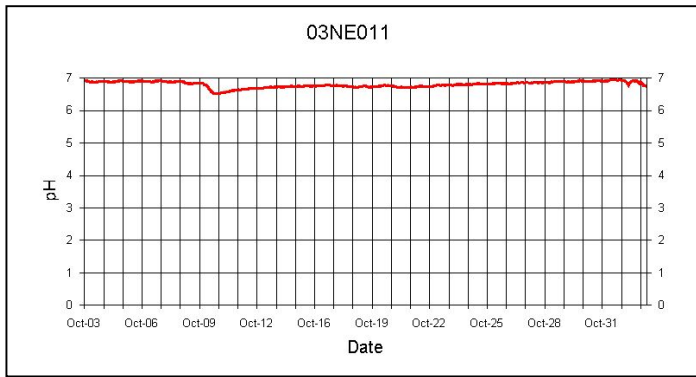
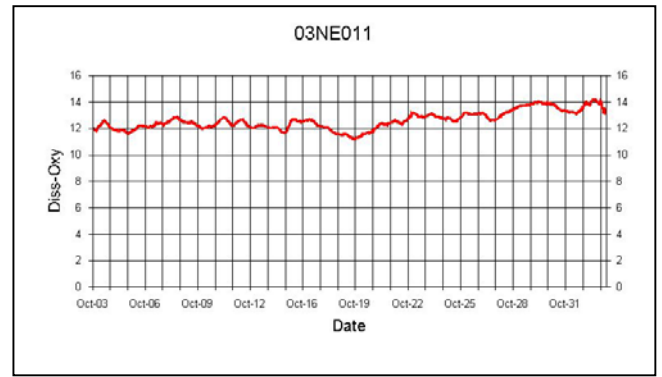
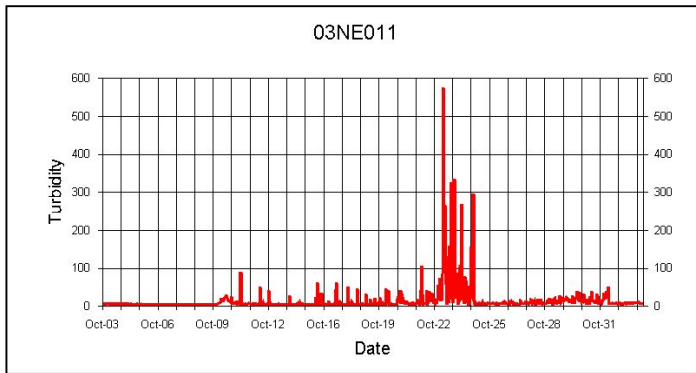
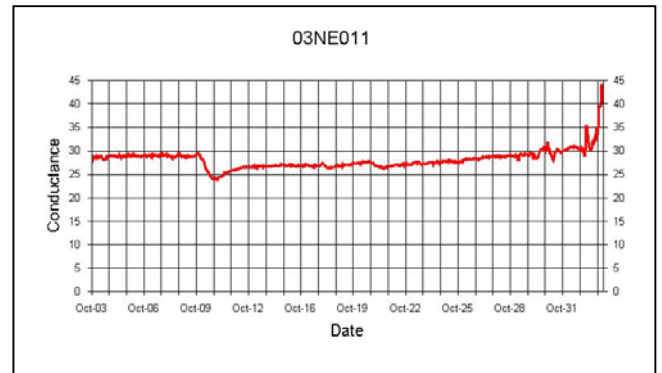
- Finally, the instrument at Lower Reid Brook showed some water quality events throughout the past month. While some parameters remained constant such as pH and dissolved oxygen (Figures 12 and 13), others such as turbidity and conductivity (Figure 14 and 15) fluctuated. The maximum turbidity value was recorded on October 22nd at 575 NTU. The turbidity values did not stay elevated in this range. It is unlikely that any development caused these spikes but rather that the increased rainfall amount (Figure 16) at this time really stirred up the soft sediment bottom where the instrument is located. It is planned that upon deployment in the spring, a new structure will be installed to lift the instrument off the bottom of the river to minimize the impact from the natural sediment. The spike in conductivity to a value of 45.9 us/cm on November 2nd may also be a result of increased rainfall amounts.
