## Real Time Water Quality Monthly Report: Lower Humber River @ Humber Village Bridge December 2003

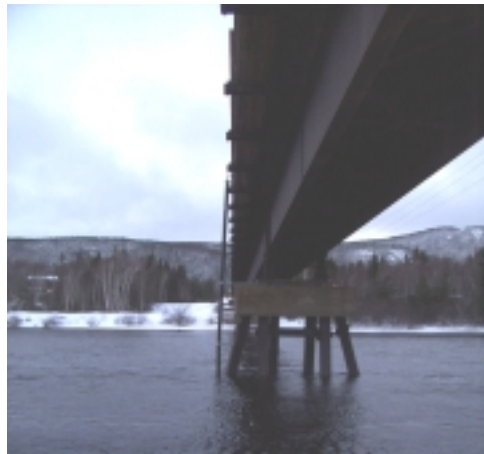
**Figure 1**

- On December 11th, 2003, provincial Department of Environment and Environment Canada staff installed the Hydrolab multi-parameter water quality probe at the Lower Humber River site on the Humber Village Bridge (see **Figure 1**).

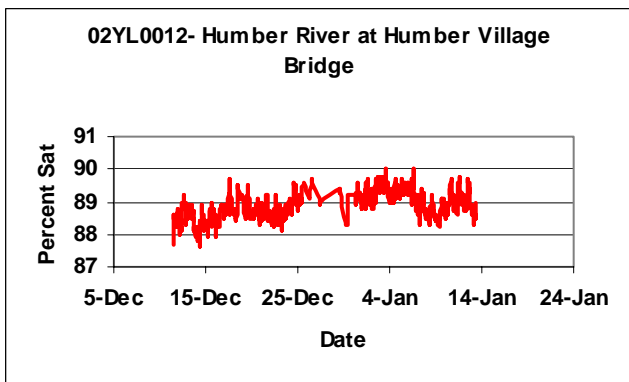
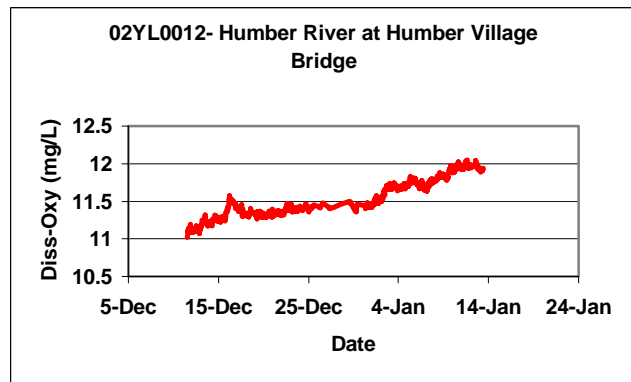
- Dissolved oxygen levels increased over this period, corresponding to decreased water temperatures. There were problems calibrating the DO sensor prior to these readings, which might account for the lower than expected percent saturation values.

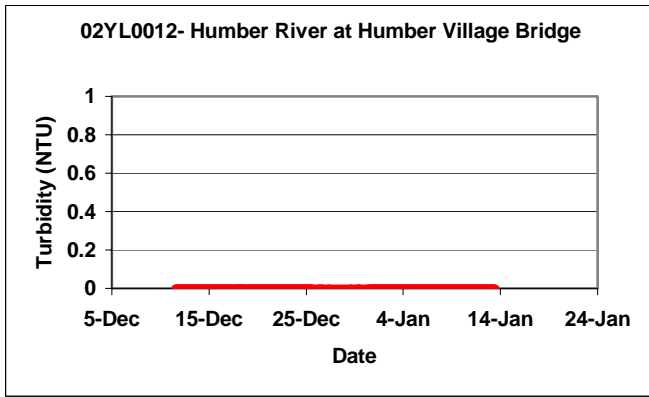
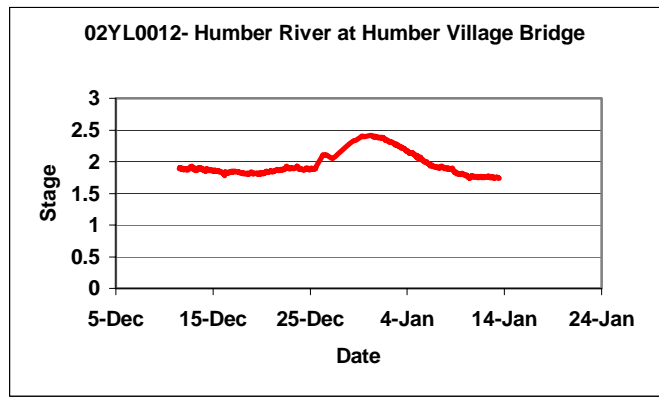
- Turbidity during this period remained at 0 NTU. Other real time water quality stations have also consistently indicated zero turbidity, so this result was not entirely out of the ordinary. However, with the increase in stage or streamflow at the beginning of January, a corresponding increase in turbidity was expected. As it was not, some problem with the turbidity sensor is suspected.
