Real Time Water Quality Monthly Report for Voisey's Bay Nickel Company Ltd. October 2005

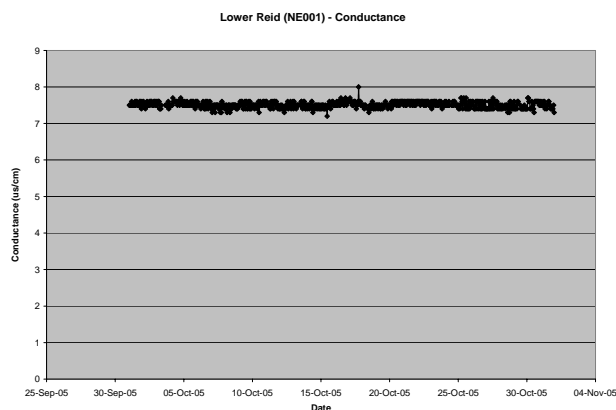
Figure 1

- Throughout the month of October, most water quality parameters at the Upper Reid Brook station remained steady at expected background levels. As can be seen by the graphs (Figures 1 & 2), pH and conductivity remained very consistent throughout the month.

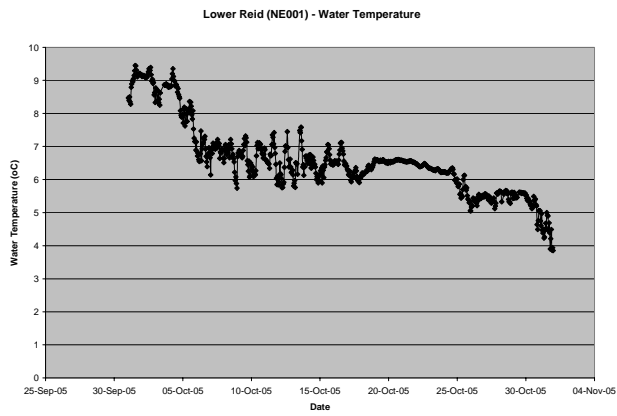
Figure 3

- Temperature has been decreasing throughout the month of October, which is expected for this time of year (Figure 3). The dissolved oxygen concentrations have been increasing which corresponds with the decreasing temperatures. (Figure 4)

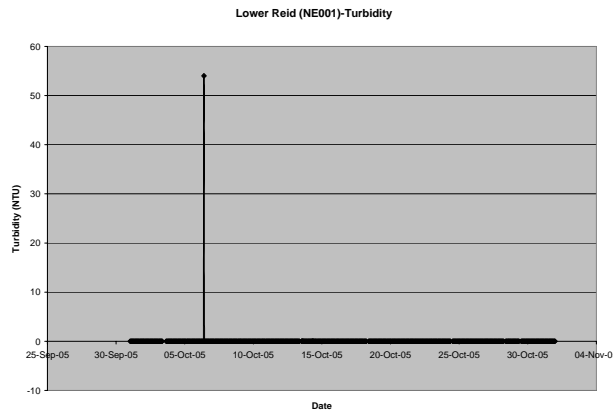
Figure 5

- Turbidity values remained at background levels (approximately 0 NTU) for the month of October with the exception of one spike on October 6th of 54 NTU (Figure 5).

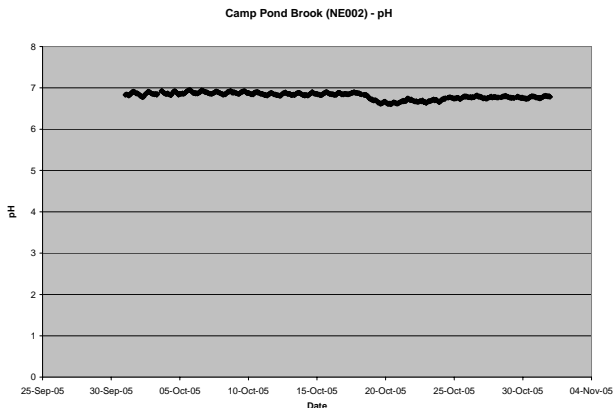
Figure 6

- The pH in Camp Pond Brook remained stable at background levels until October 18th when the pH levels dropped. The levels remained low until October 21st when levels began to increase. pH has since levelled off to approximately background levels. (Figure 6).
- At the same time, there was a spike in conductance to 23.8 us/cm. The conductance returned to background levels on October 19th with two additional (but smaller) spikes on October 21st and October 27th. (Figure 7).

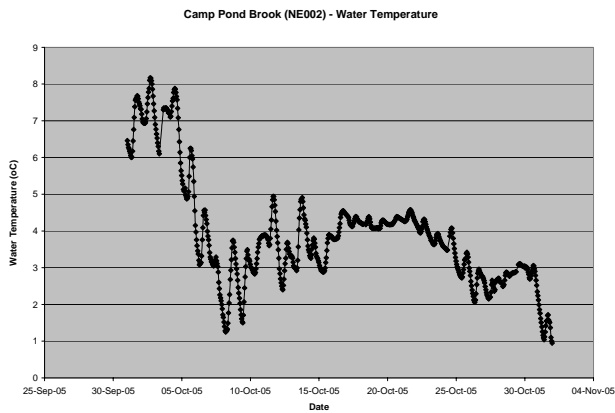
Figure 8

- Temperature showed fluctuations throughout the month of October but a definite increasing trend. This is typically for this time of year. (Figure 8). The dissolved oxygen shows an increase during the month which corresponds to decreasing temperature. (Figure 9).

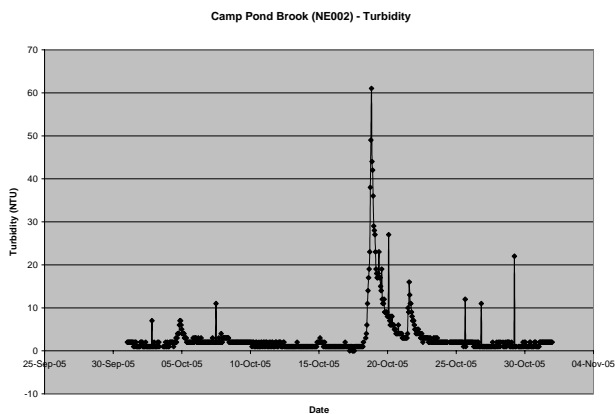
Figure 10

- Turbidity remained at background levels until October 18th. (Figure 10). On this date a significant spike of 61 NTU was observed. There were a couple of smaller spikes on October 20th and October 21st of 27 NTU and 16 NTU respectively before falling to normal background levels. There is no definite explanation at this time but there was a significant increase in stage between October 17th and October 22nd. (Figure 11). There were also three sporadic spikes towards the end of the month with a maximum of 22 NTU.

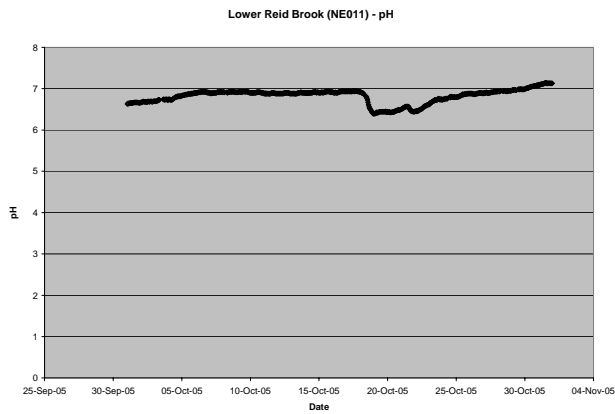
Figure 12

- The pH in Lower Reid Brook remained stable at background levels until October 18th when the pH levels dropped. The levels began to increase on October 22nd and continued to increase until pH was slightly above background levels. (Figure 12).
- At the same time, there was a drop in conductance down to 14 us/cm. The conductance remained at this level until October 24th when the levels began to increase. Levels are currently at 19 us/cm. (Figure 13). Throughout the month of October conductance concentrations remained within background levels.

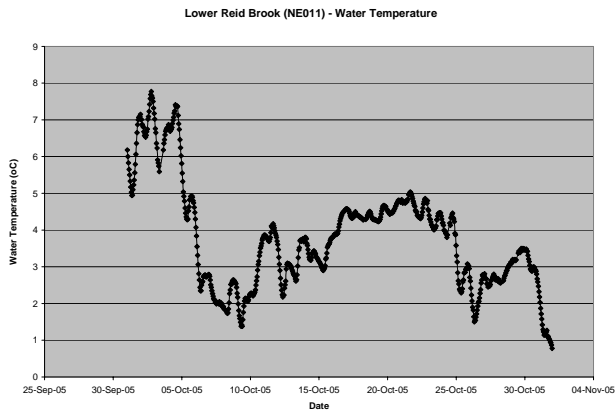
Figure 14

- Temperature showed fluctuations throughout the month of October but a definite increasing trend. This is typically for this time of year. (Figure 14). The dissolved oxygen also shows fluctuations with an increasing trend which corresponds to the decreasing temperature. (Figure 15).

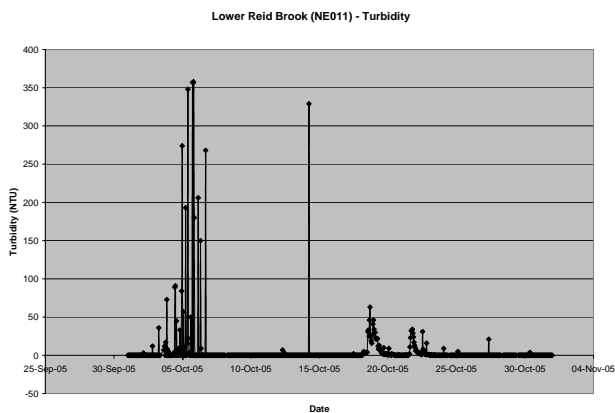
Figure 16

- As noted in the previous September monthly report, all three Datasondes were maintained and calibrated on September 25th and 26th, 2005. The instruments will be removed in early November for the winter months.
- As noted in the previous September monthly report, the extreme high water level of Lower Reid Brook prevented the Hydrolab from returning to the installation developed in July. It is currently on the sediment bottom.

- Turbidity spikes were seen during the beginning of October with a maximum of 357 NTU. (Figure 16). There is no explanation at this time but it is possible that these spikes were due to the fact that the Hydrolab is lying on the sediment bottom instead of in its usual installation. Excessive water levels during the last installation prevented the instrument from being installed in its usual setup. One additional large spike was seen on October 14th. There were two smaller spikes on October 18th and October 21st of 63 NTU and 34 NTU respectively. These spikes could be due to high stage levels shown in Figure 17.
