Total Methylmercury (ng/L) in Water

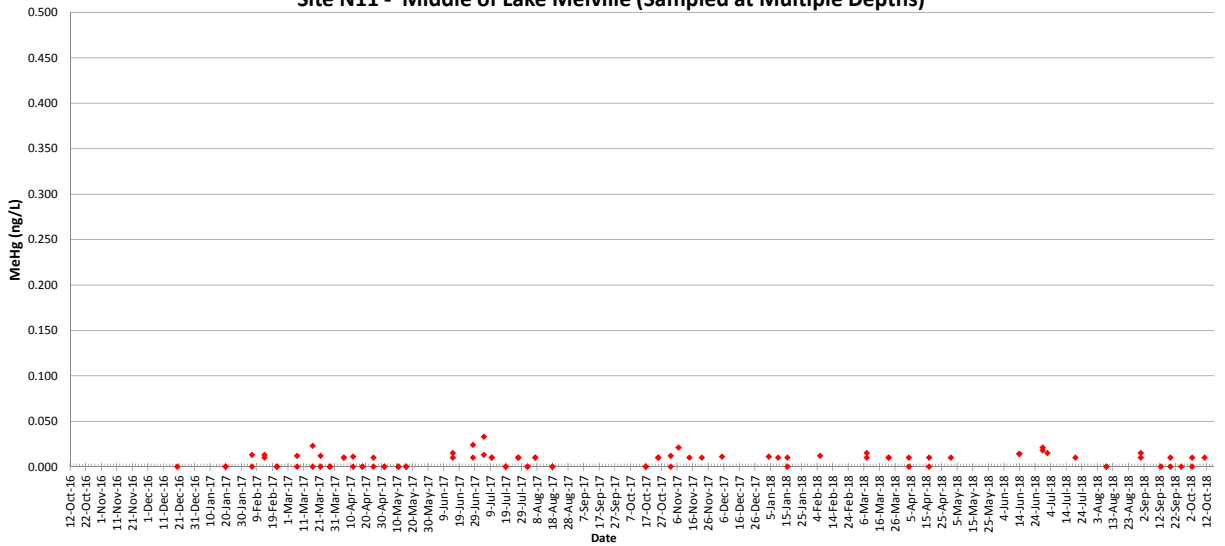
Site N11 - Middle of Lake Melville (Sampled at Multiple Depths)

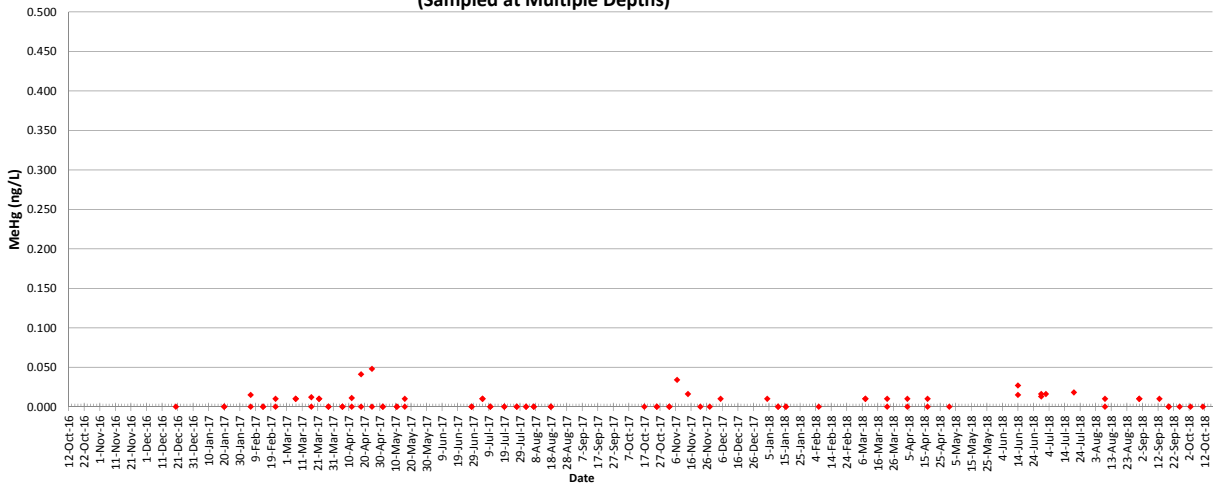
Site N12 - Northeastern Lake Melville near Neveisik Island (Sampled at Multiple Depths)

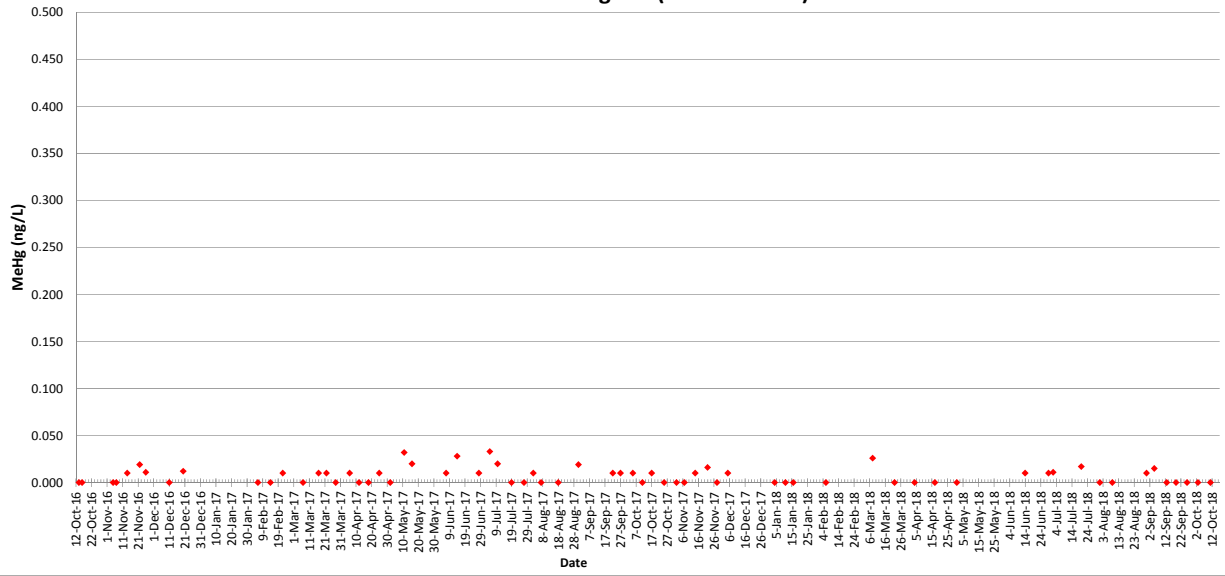
Site N13 - Near Rigolet (Lake Outflow)
