**Real Time Water Quality Monthly Report  
Rattling Brook below Bridge (VBNC)  
December 2006-January 2007**

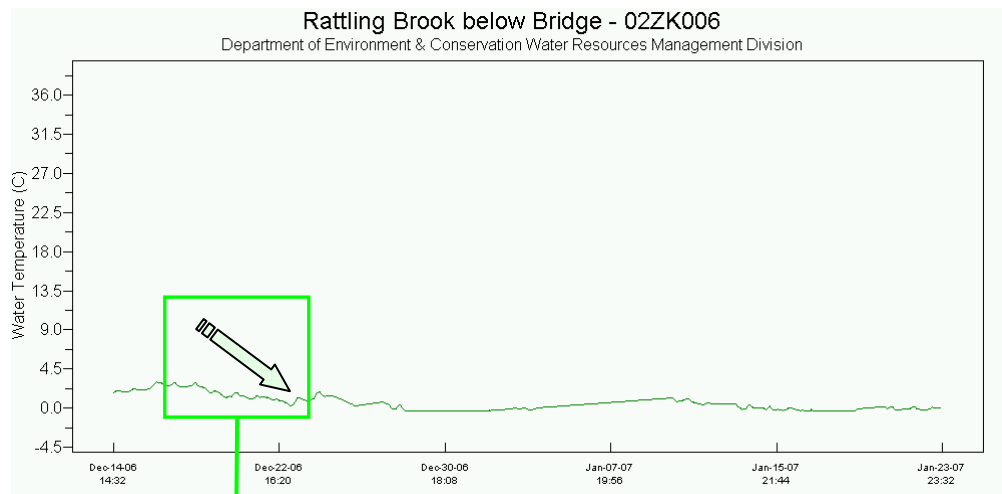
Figure 1

- This monthly report interprets the data from the Rattling Brook RTWQ station in Long Harbour for the period of December 12<sup>th</sup>, 2006 – January 23<sup>rd</sup>, 2007.
- The water temperature (**Figure 1**) readings for Rattling Brook remained fairly consistent over the deployment period with a slight decrease in temperatures. This is expected at this time of the year with a temperature range of -0.28 - 3.02 °C.

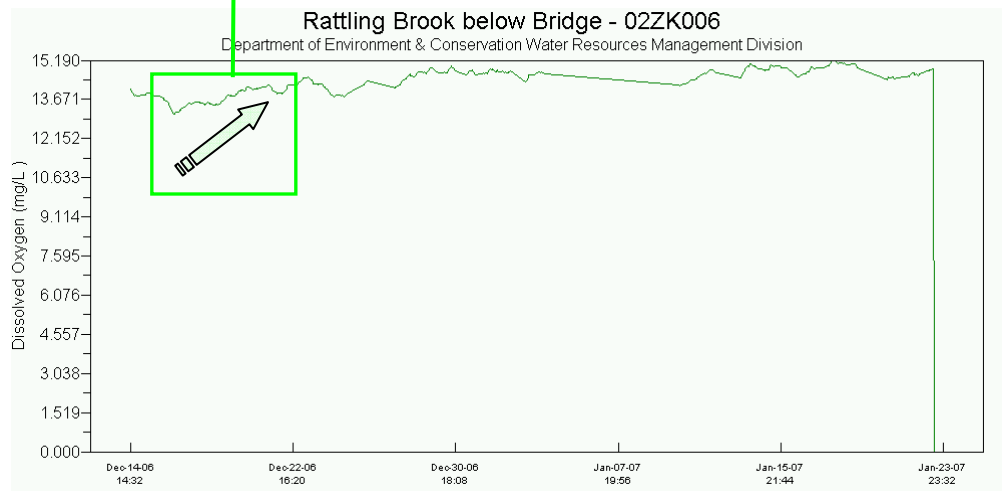
Figure 2

- The dissolved oxygen values (**Figure 2**) remained fairly consistent over the deployment period with a slight increase in values. This is consistent with the slight decrease in temperature seen in **Figure 1**. The dissolved oxygen values ranged from 13.12 mg/L to 15.19 mg/L. These values fall within the recommended CCME Protection of Aquatic Life guidelines for dissolved oxygen (cold water/other life stages – above 6.5; warm water/other life stages – above 5.5; warm water/early life stages – above 6; cold water/early life stages – 9.5 mg/L).

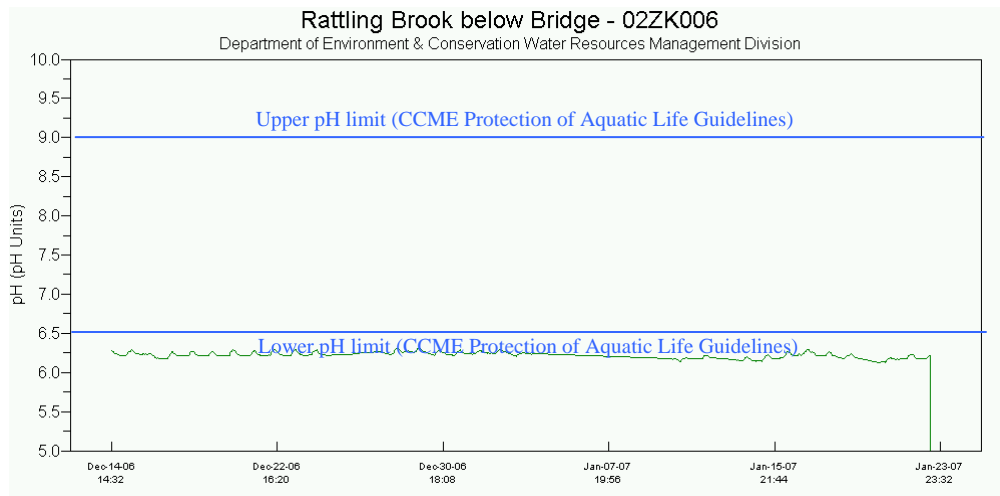
**Figure 3**

- The pH values (**Figure 3**) for Rattling Brook station remained consistent throughout the deployment period. The pH values ranged from 6.13 – 6.31 with all values falling outside the recommended range (6.5 – 9.0) for the CCME Protection of Aquatic Life guidelines due to the naturally acidic nature of NL waters.

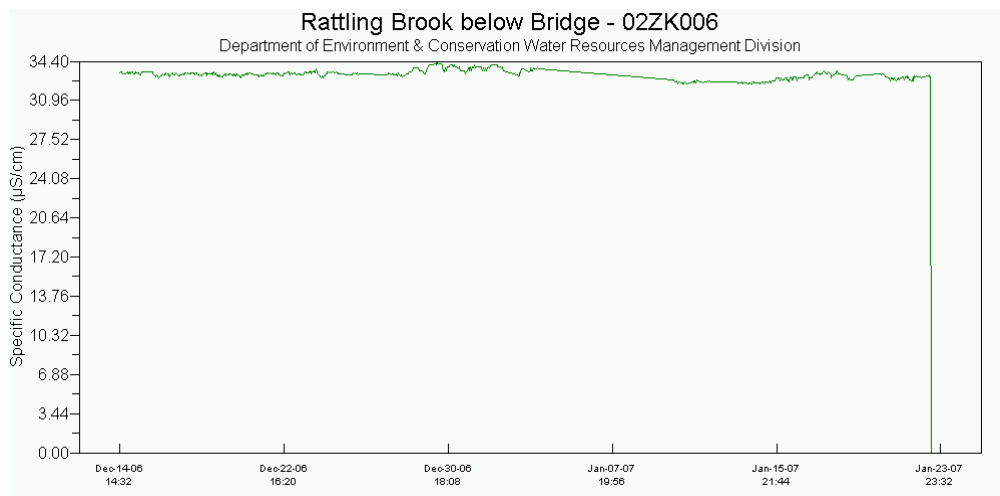
**Figure 4**

- The specific conductivity values (**Figure 4**) remained consistent throughout the deployment period with values ranged from 32.4 – 34.4  $\mu\text{S}/\text{cm}$ .

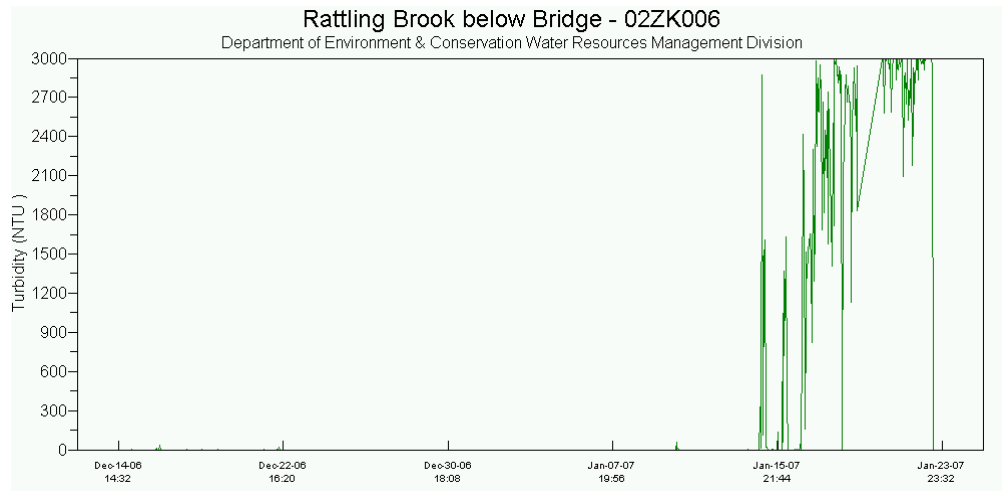
**Figure 5**

- The turbidity values (**Figure 5**) remained near 0 NTU until January 15<sup>th</sup>, 2007. The turbidity values after that date reached the maximum measurable values for the instrument of 3000 NTU. This was likely due to the alga/plant material that was found intertwined on the turbidity sensor when the instrument was removed on January 23<sup>rd</sup>, 2007 (see Picture 3 in Appendix A). The casing was removed and taken to a machine shop for retrofit of stainless steel screen to ensure that this does not occur again.

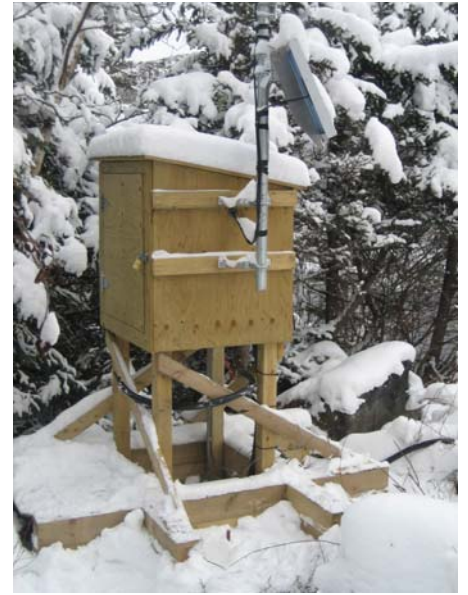
**Picture 2: Hydrometric Hut at Rattling Brook below Bridge**

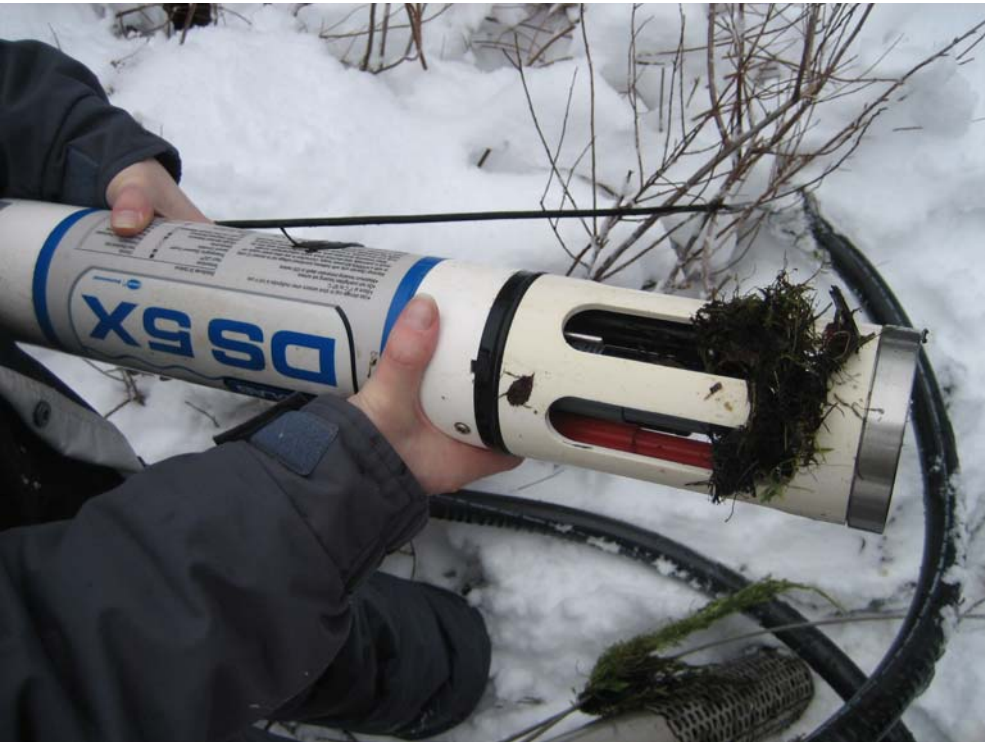
**Picture 3: Alga/plant material that was found intertwined on the Datasonde when instrument was removed on January 23<sup>rd</sup>, 2007**
