Real Time Water Quality Monthly Report for Voisey's Bay Nickel Company Ltd. October 2004

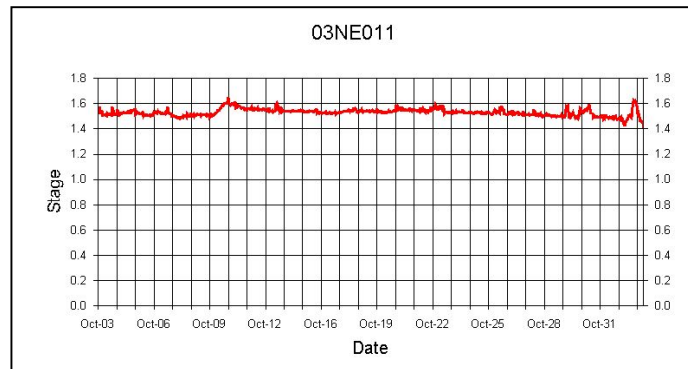
Figure 15

- Finally, the instrument at Lower Reid Brook showed some water quality events throughout the past month. While some parameters remained constant such as pH and dissolved oxygen (Figures 12 and 13), others such as turbidity and conductivity (Figure 14 and 15) fluctuated. The maximum turbidity value was recorded on October 22nd at 575 NTU. The turbidity values did not stay elevated in this range. It is unlikely that any development caused these spikes but rather that the increased rainfall amount (Figure 16) at this time really stirred up the soft sediment bottom where the instrument is located. It is planned that upon deployment in the spring, a new structure will be installed to lift the instrument off the bottom of the river to minimize the impact from the natural sediment. The spike in conductivity to a value of 45.9 us/cm on November 2nd may also be a result of increased rainfall amounts.
