Real Time Water Quality Monthly Report: Lower Humber River @ Humber Village Bridge May-June 2004

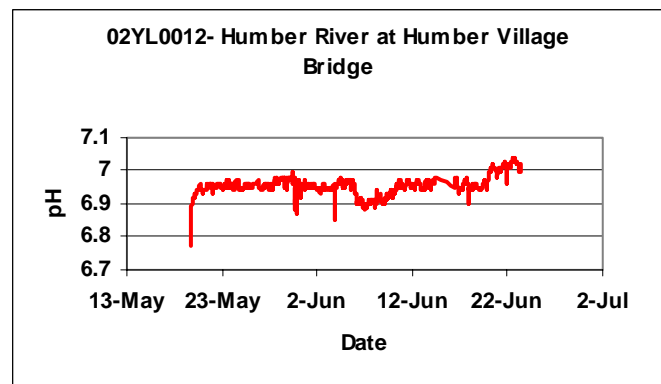
- During the period from May 19th, 2004 to June 23rd, 2004 parameters displayed normal behaviour. Water temperature continued to increase as ambient air temperature increased. pH displayed normal fluctuations in range with typical pH values for the Humber River.

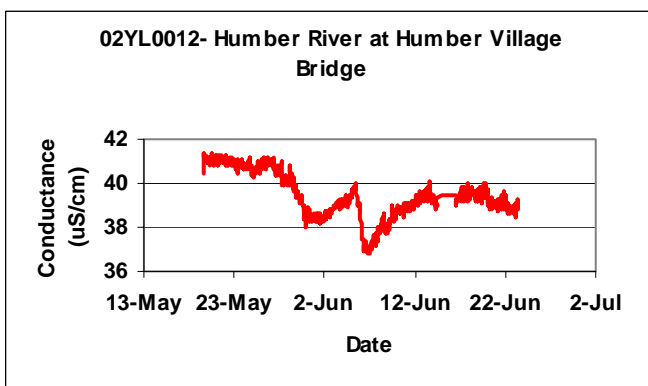
- Conductance values for this period fell within normal range for the Humber River. A dip in conductance at the beginning of June corresponds with a peak in stage or streamflow. Dissolved solids tend to become more dilute with increased runoff. Runoff from snowmelt is mostly over by this point in time.

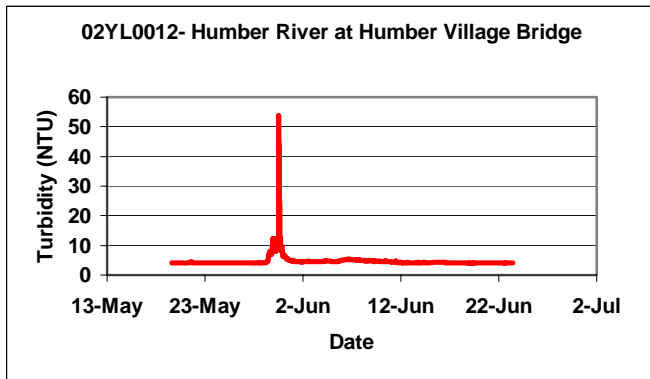
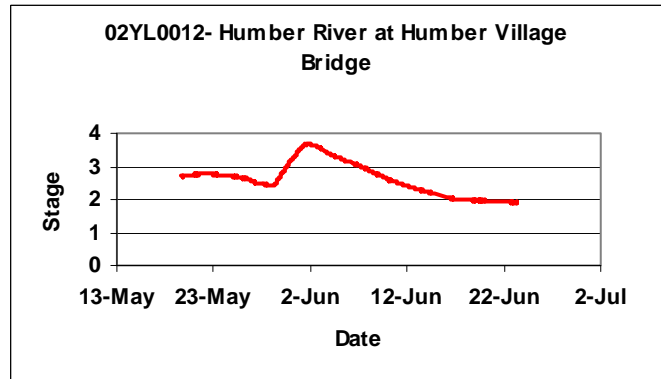
- Background turbidity levels were again slightly above 0 NTU during this period. A large spike in turbidity occurred in early June corresponding to the rising leg in stage or streamflow. The heavy rainfall event in early June and corresponding runoff from the watershed can account for the sharp peak in turbidity. This spike was particularly noticeable as many farms in the Humber Valley region were preparing fields for planting.
