# Total Methylmercury (ng/L) in Water

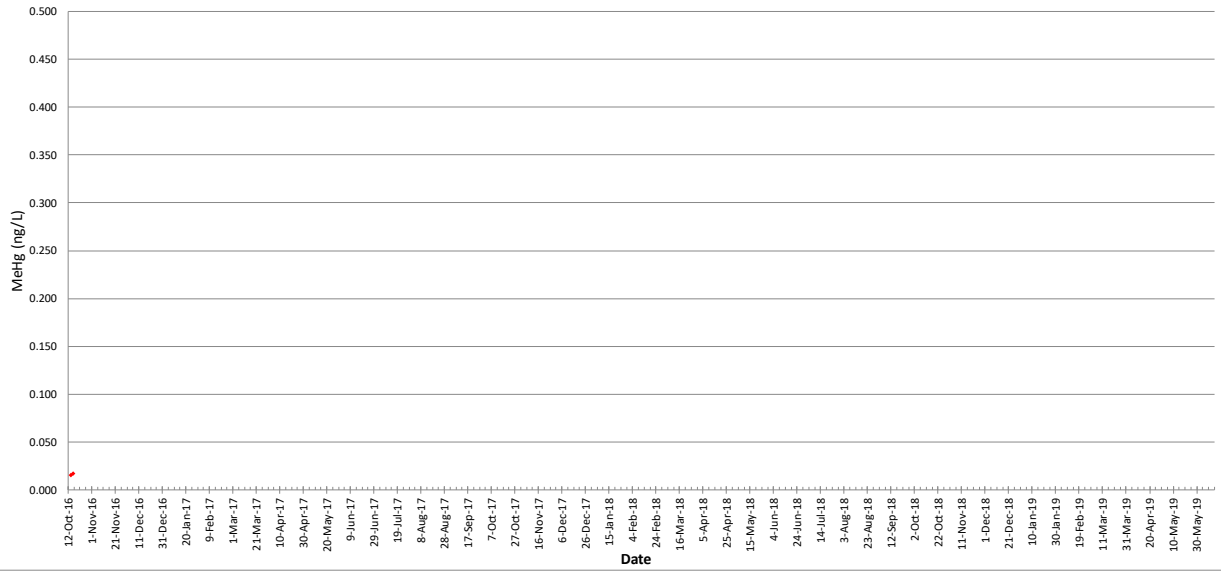
Site N3 - Reservoir between Pinus River and Upper Brook

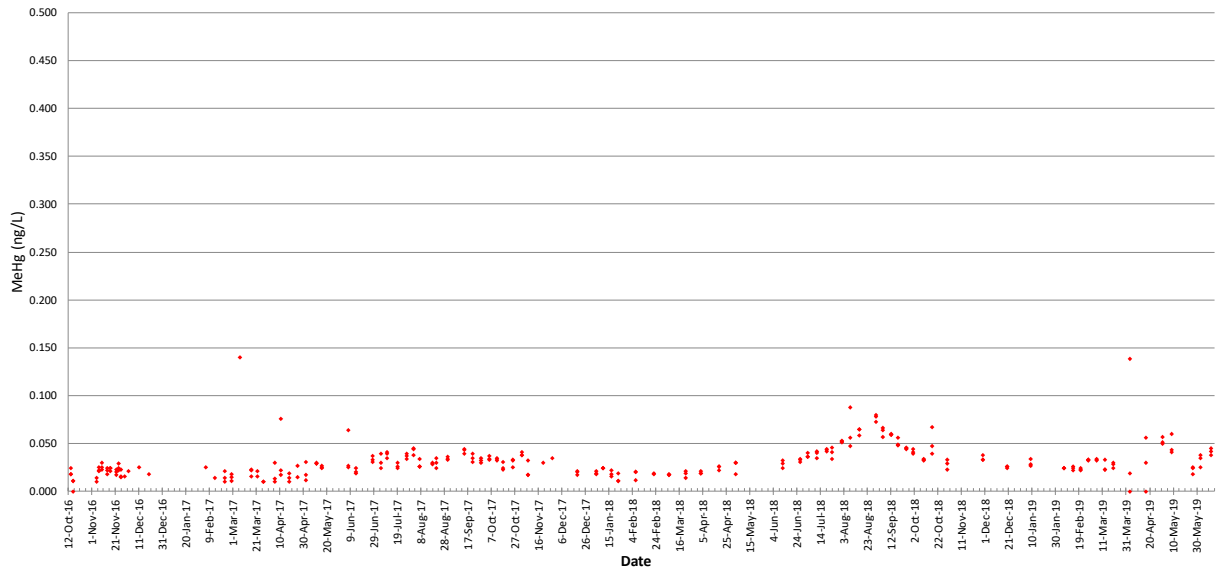
Site N4 - Above Muskrat Falls (Sampled at Multiple Depths)

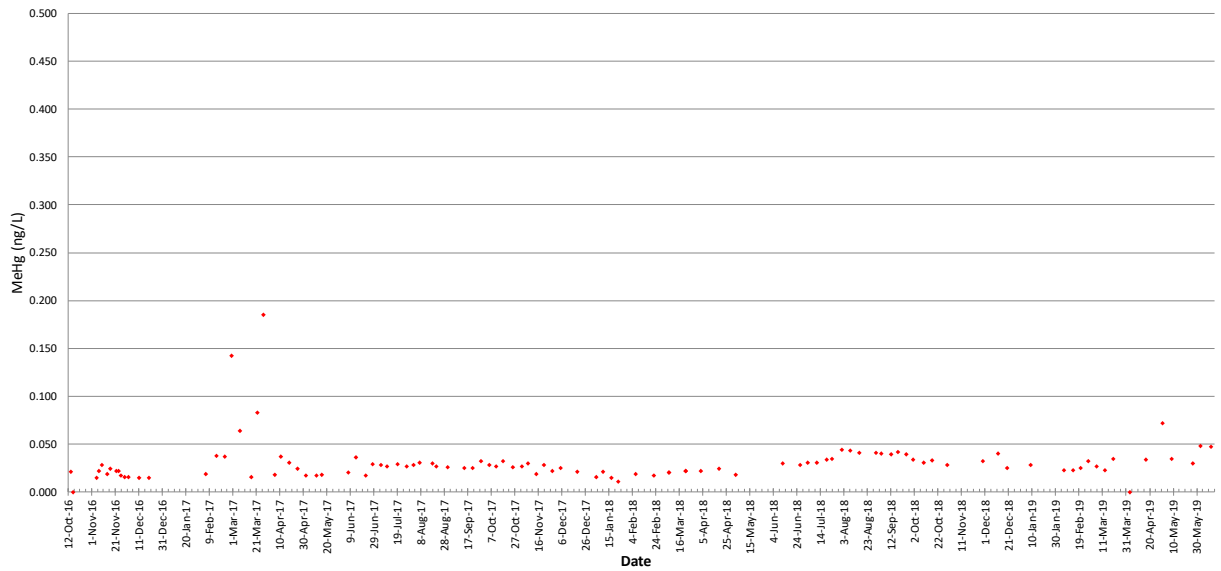
Site N5 - Below Muskrat Falls

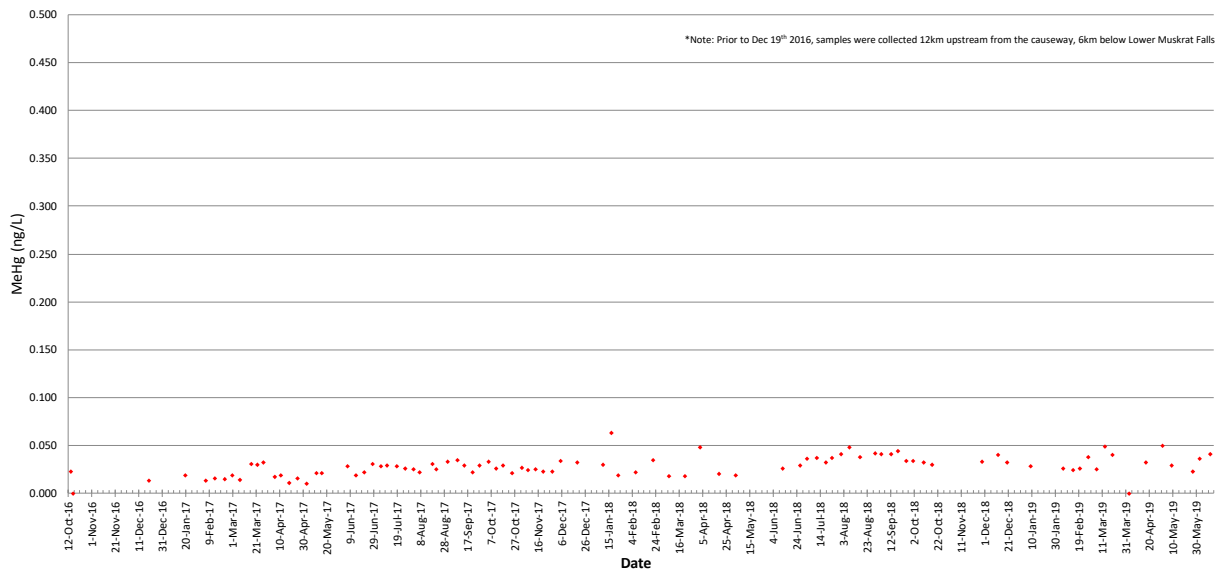
Site N6 - Causeway

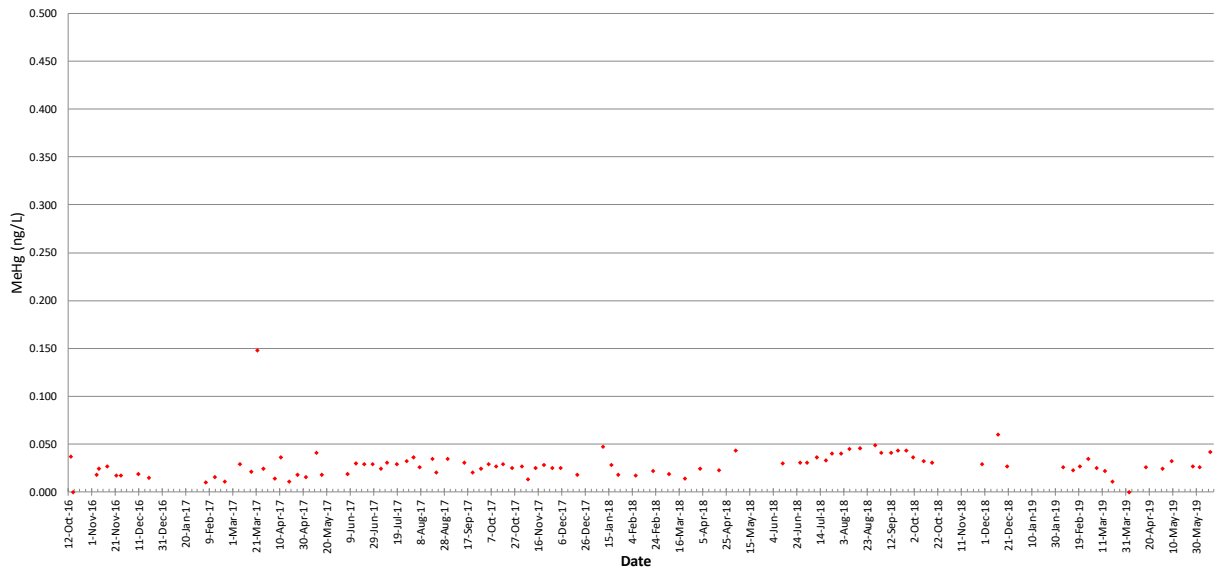
### Site N7 - English Point

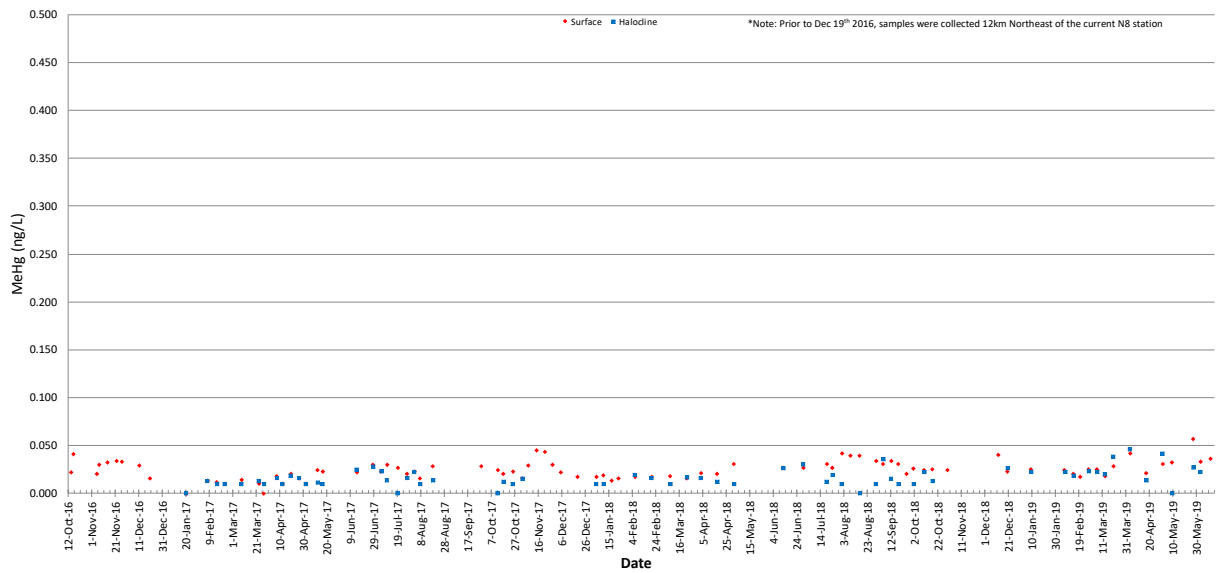
### Site N8 - Goose Bay East of Rabbit Island (Sampled at Multiple Depths)

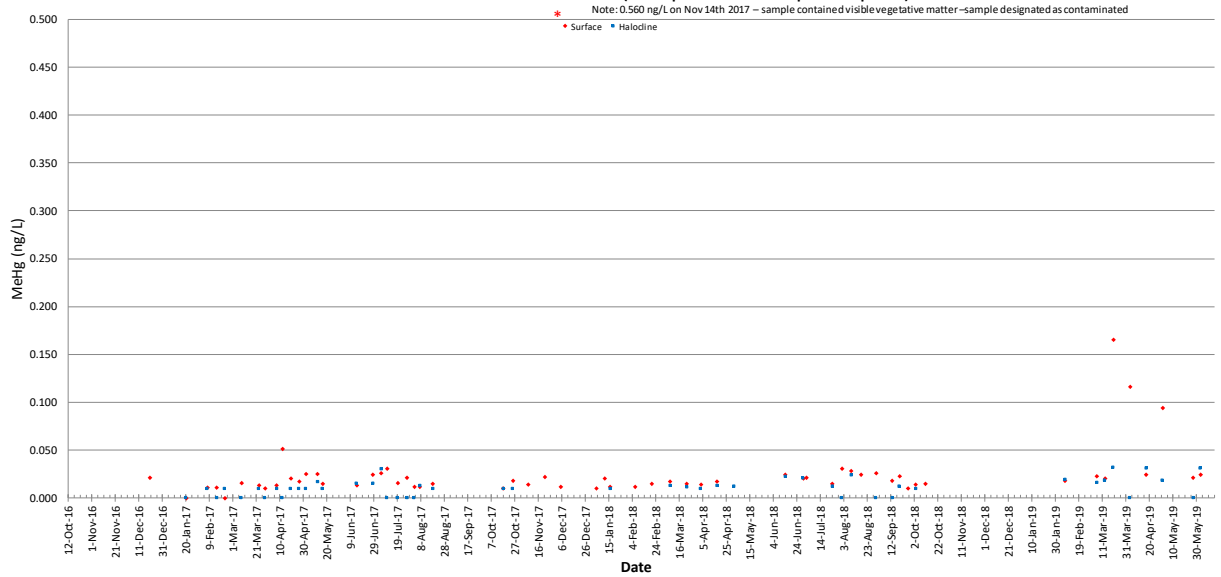
### Site N9 - Inflow to Lake Melville (Sampled at Multiple Depths)

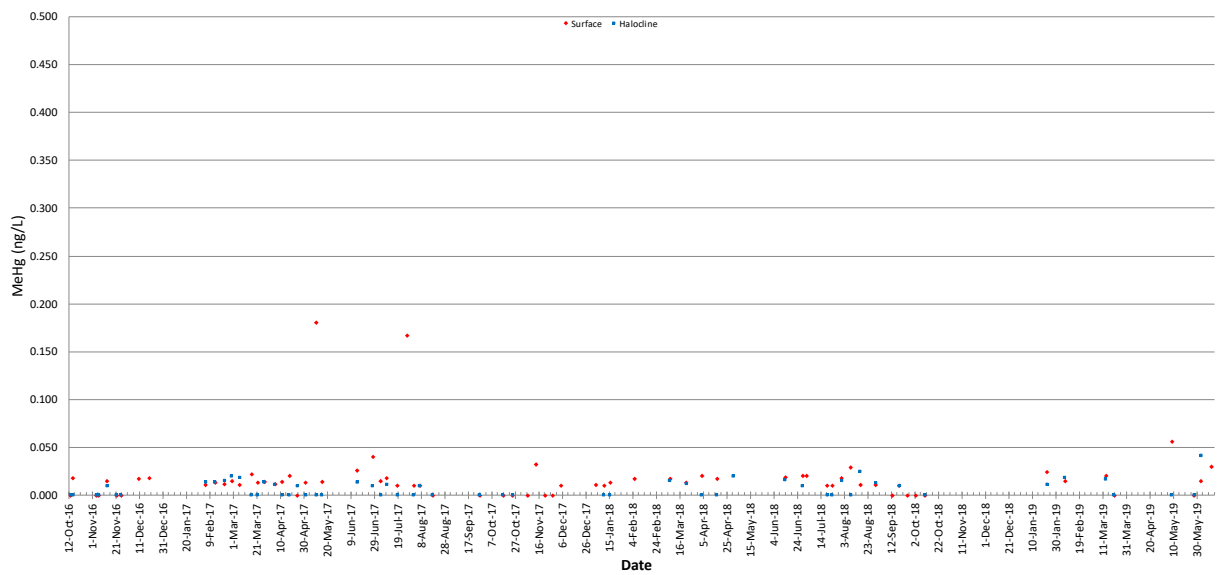
### Site N10 - Middle of Lake Melville (Sampled at Multiple Depths)

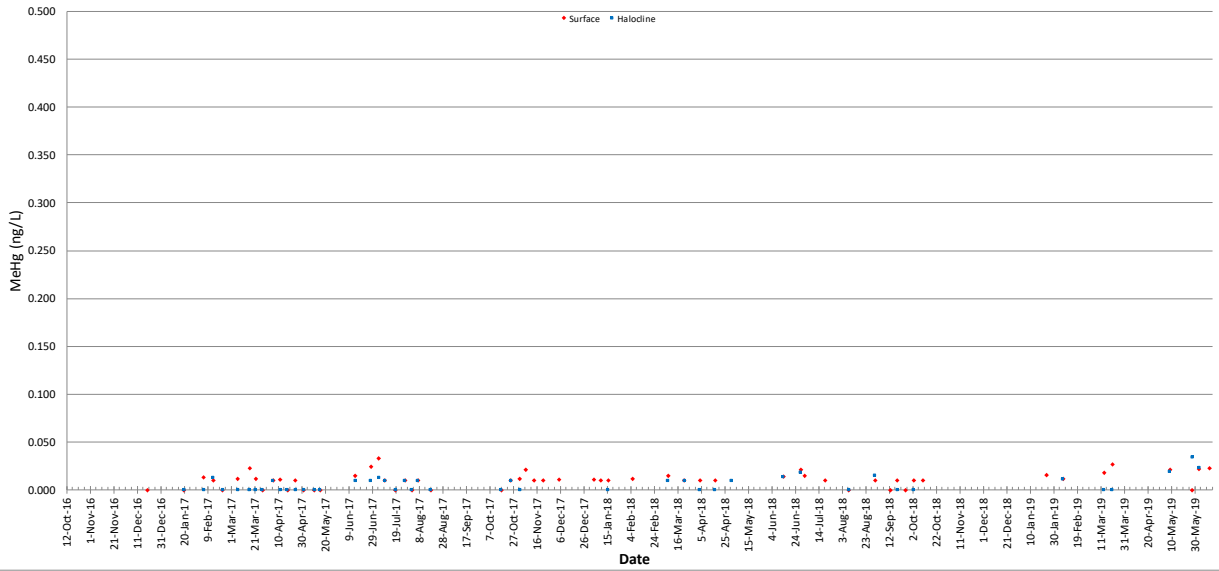
Site N11 - Middle of Lake Melville (Sampled at Multiple Depths)

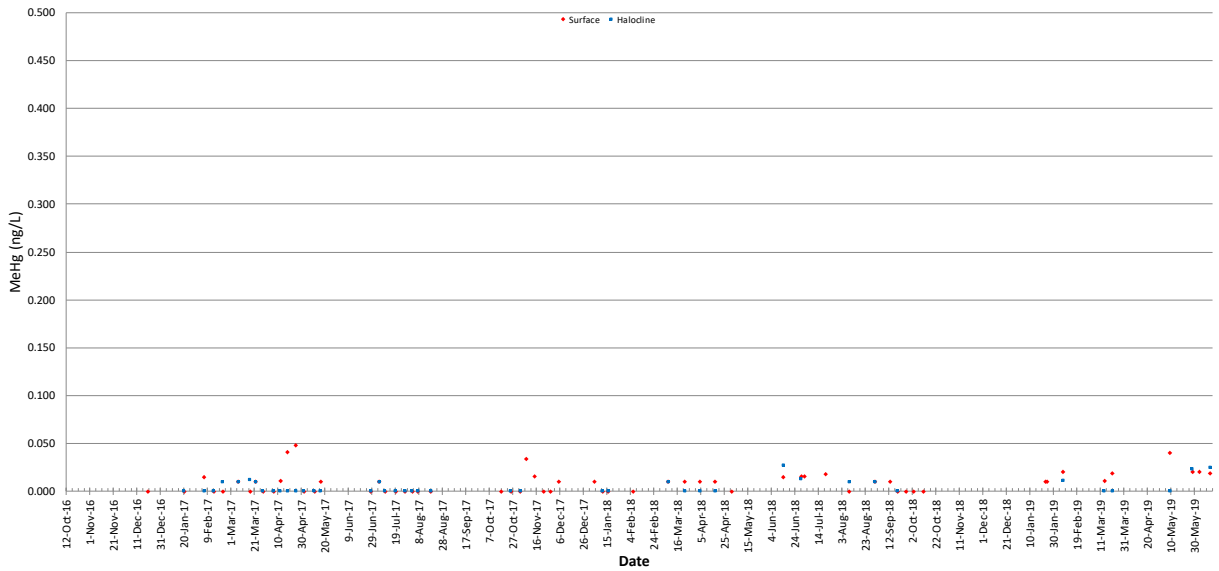
Site N12 - Northeastern Lake Melville near Neveisik Island (Sampled at Multiple Depths)

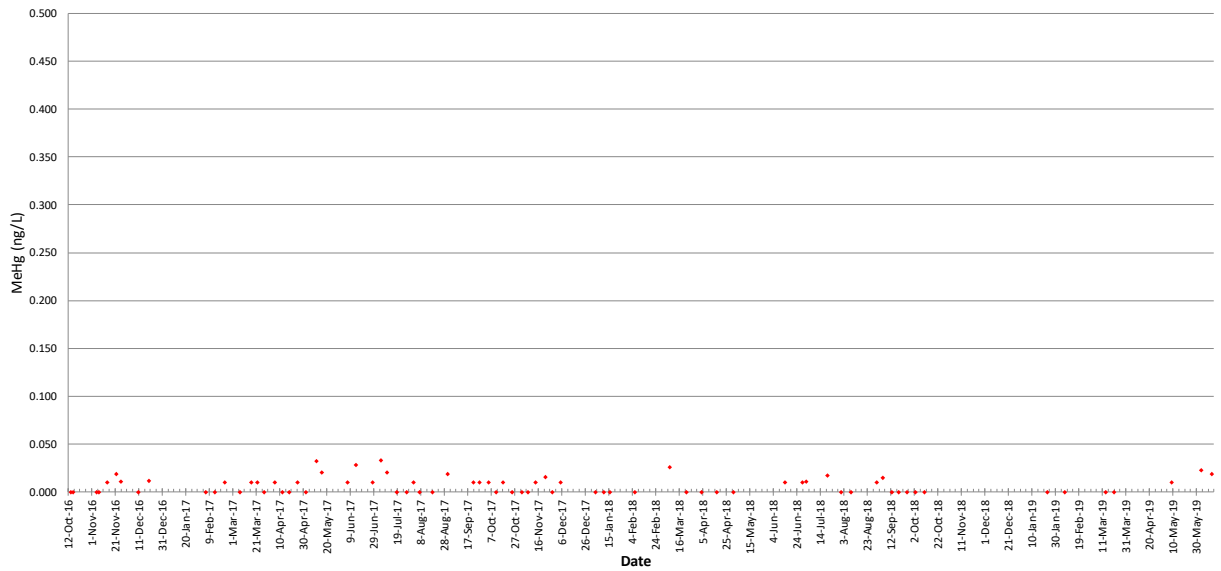
Site N13 - Near Rigolet (Lake Outflow)
